SEGMENT COMPLETION REPORT

Federal Aid Project No. F-3-17

Region III-B Fisheries Studies

Job No. 5 Pollution Studies

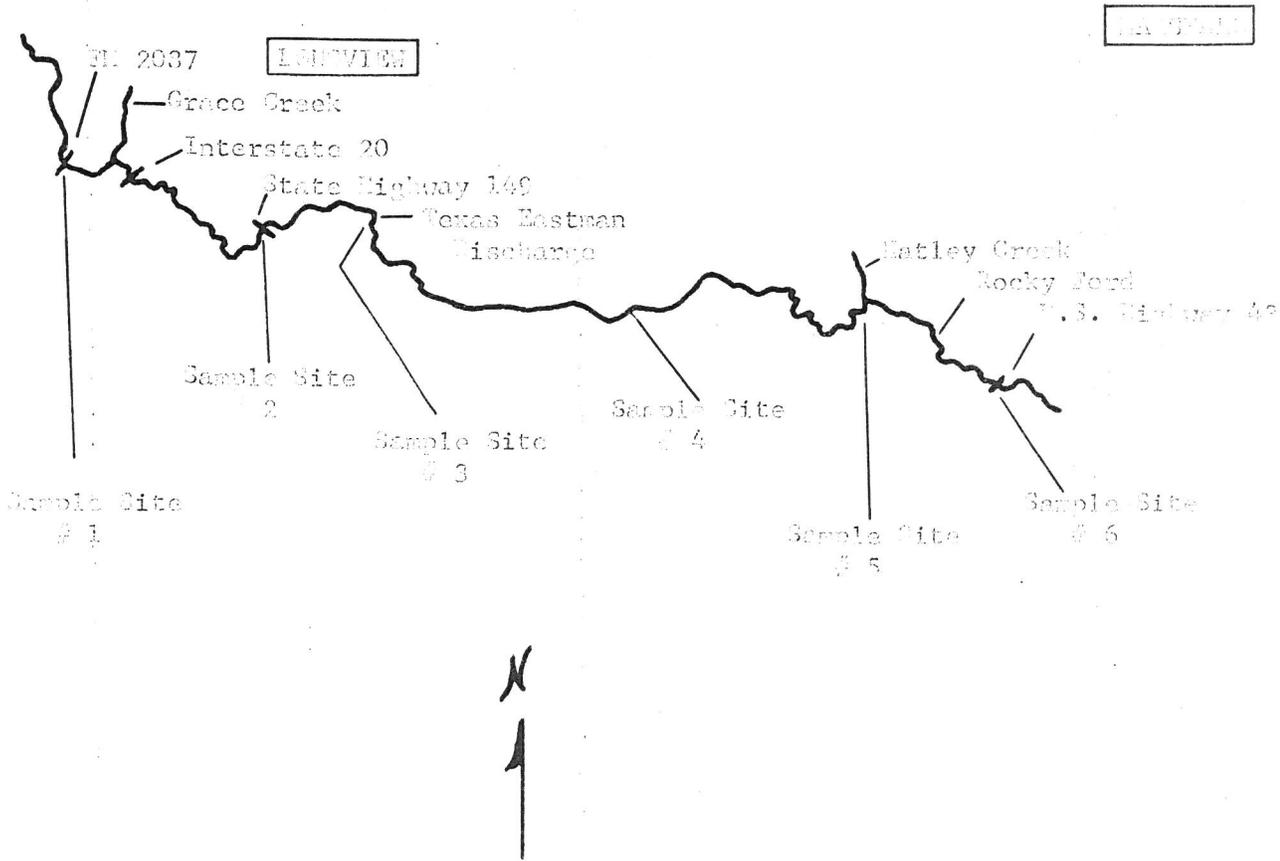
Figure 1. Sabine River showing designated sampling sites.

A monitor procedure system was initiated between F-3-R project personnel and Region III Chemist M. O. Green. Sampling sites designated in Figure 1 have been established for future pollution investigations. Upon a report of pollution in the Sabine River, sampling will be initiated at the designated stations.
